# **FLOOD PLAIN INFORMATION**

**WINOOSKI RIVER — LITTLE RIVER — THATCHER BROOK**

## **TOWN OF WATERBURY • VERMONT**

**PREPARED FOR  
DEPARTMENT OF WATER RESOURCES, STATE OF VERMONT  
BY  
DEPARTMENT OF THE ARMY, NEW YORK DISTRICT, CORPS OF ENGINEERS  
MARCH 1973**

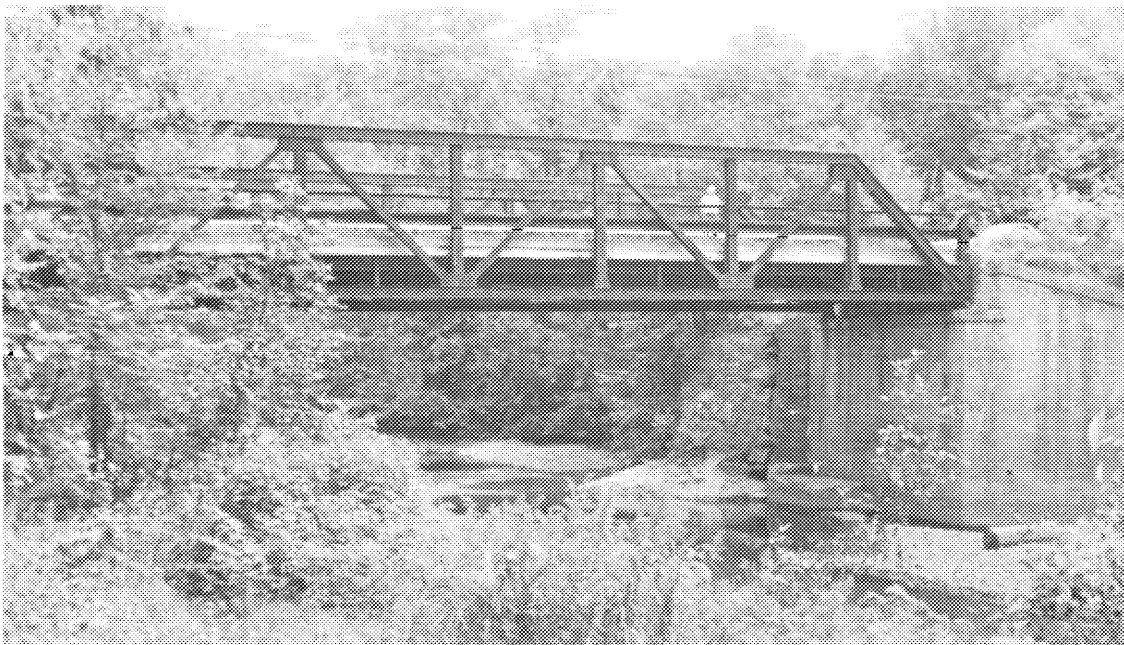
**Figure 2** - Abandoned Route 2 Bridge over Little River. Bridge opening inadequate to pass major flood.

Three bridges over Thatcher Brook would be submerged as would Old Route 2 Bridge over Little River.

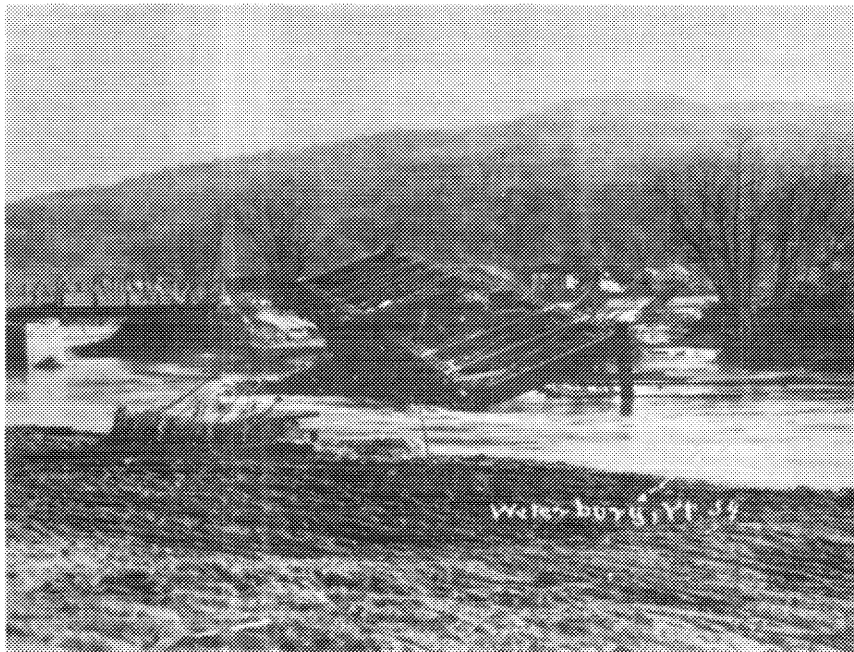
**Figure 8** - Former bridge at above site, destroyed in 1927 flood.

"Two spans of the new iron bridge across the Winooski on South Main Street went out when the doubleway bridge between Middlesex and Waterbury came down the river and hit it. The Winooski Street bridge yielded to a tremendous water pressure from the river and a backup caused by debris along the line of trees bordering the village cemetery, where a barricade was found in some places fifteen feet high. Two houses and the Middlesex Bridge were the death of the railroad bridge, No. 71, downstream of Waterbury, which withstood three blows before giving way.

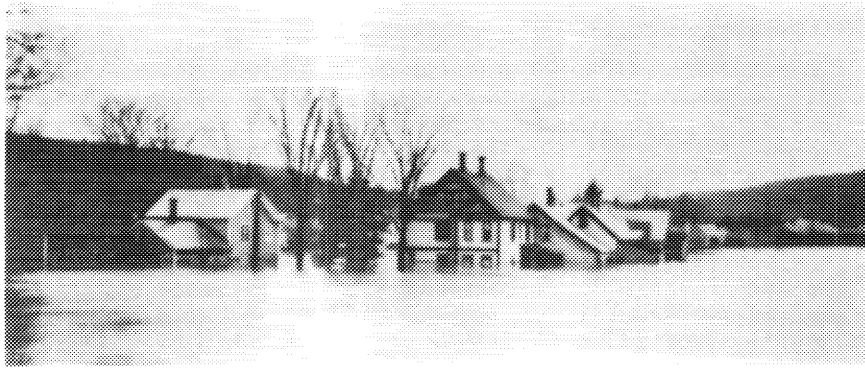
**Figure 9**  
Randall Street  
looking toward  
State Hospital  
in 1927.

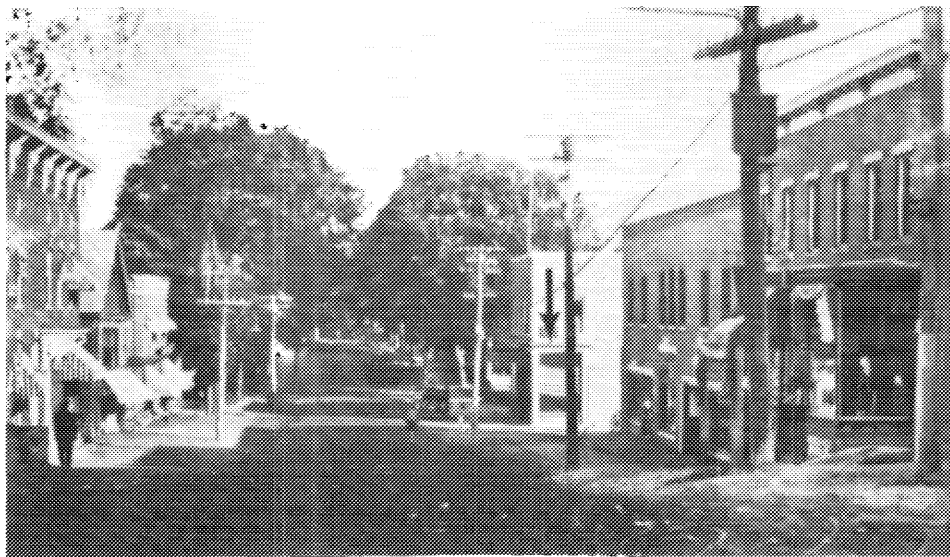
**Figure 11** - Main St. Waterbury; 1927 flood reached base of pole bearing telephone connection box in right foreground and to black horizontal line over window displaying flag.

"The Winooski Valley, over a mile wide at Waterbury, was a great, awe-inspiring lake. Water flowed over Main Street at varying depths according to the street level, but in many places it was ten and even fifteen feet deep in the street. At the high point of the flood the water reached just to the top of Bank Hill in the center of the town. The railroad station was submerged to its roof. Between six and seven feet of water flowed over the office floor at the Waterbury Inn. A train load of milk in the railroad yard was all but submerged and two trainmen spent the night on the water tower clinging to it.

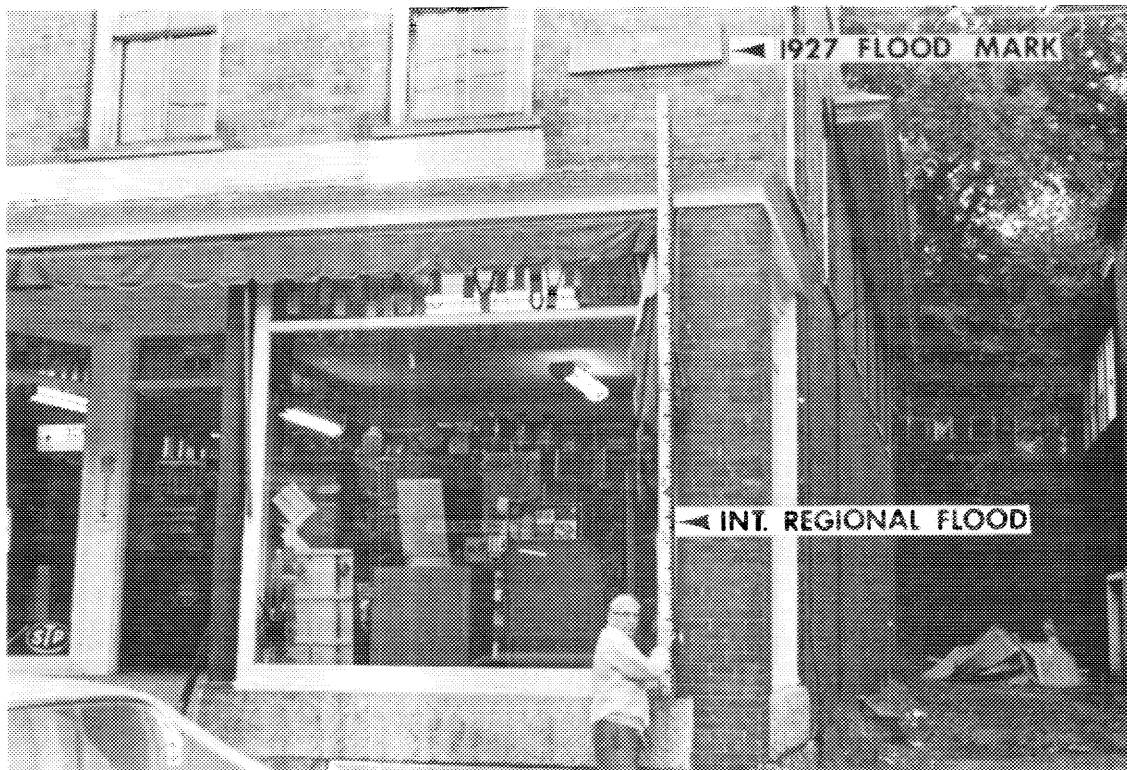
**Figure 12** - 1927 highwater mark on Elm Street building, near corner of Main Street. IRF would reach point indicated. SPF would be 12 ft. higher.

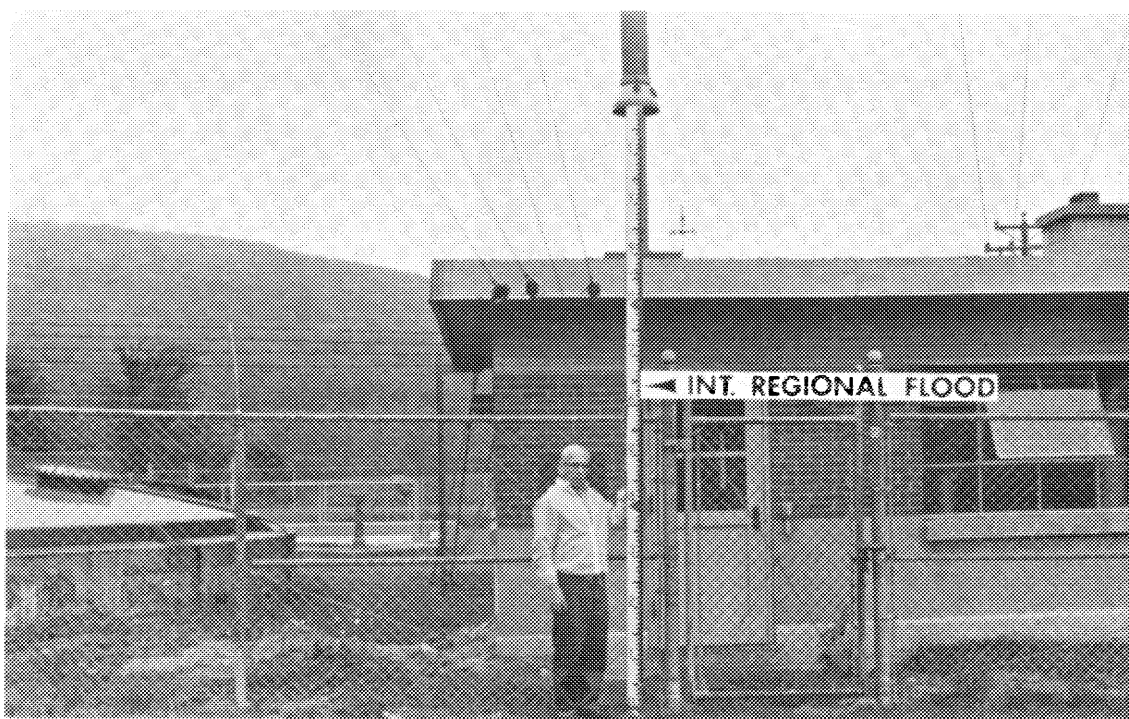
**Figure 15** - Waterbury State Hospital Wastewater Treatment Plant showing future flood elevation.

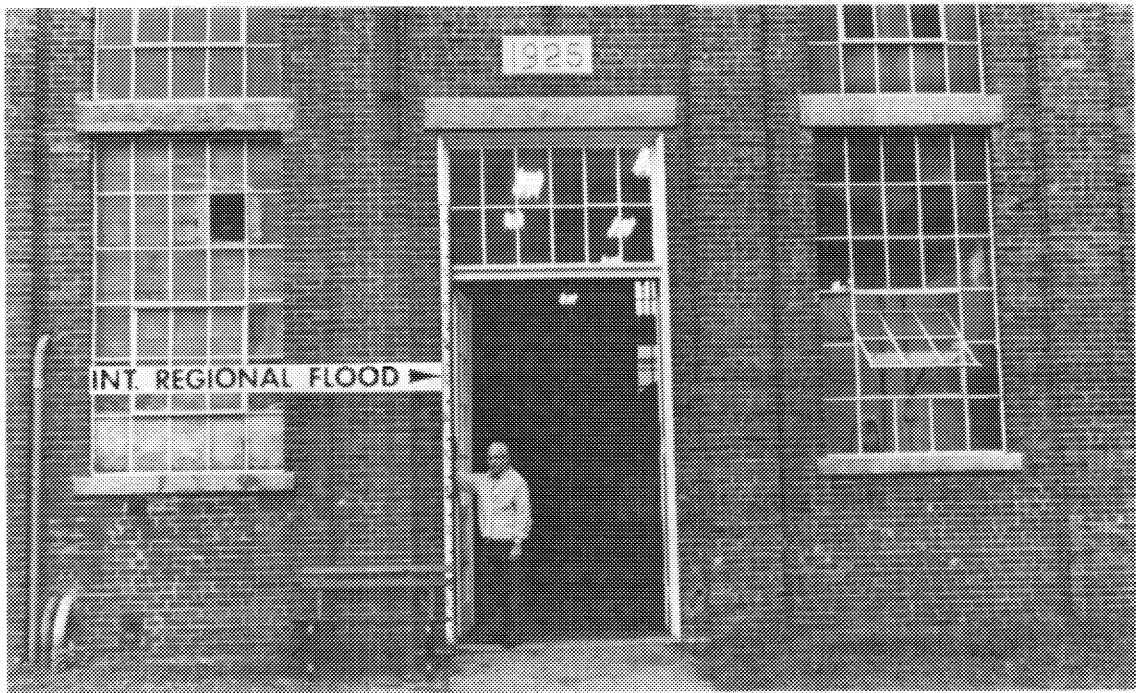
**Figure 16** - Steam plant at Waterbury State Hospital showing relative flood heights. SPF would exceed IRF by 11 ft.

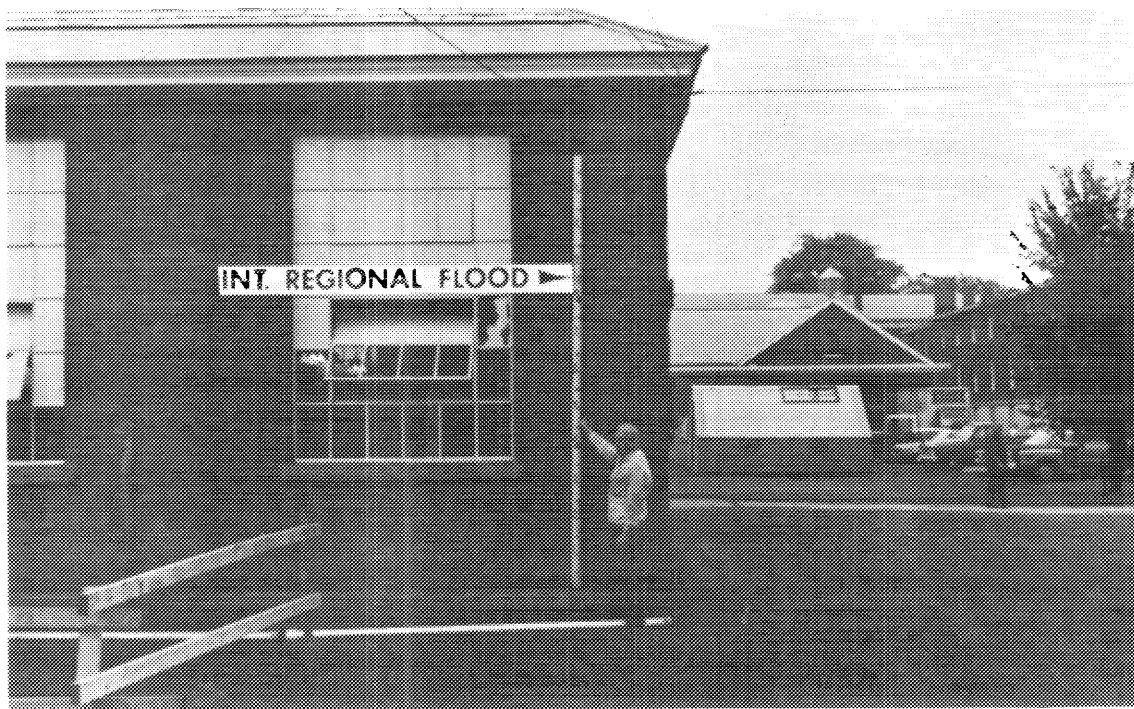
**Figure 17** - Future flood heights at laundry building at State Hospital. SPF would exceed IRF by 11 ft.

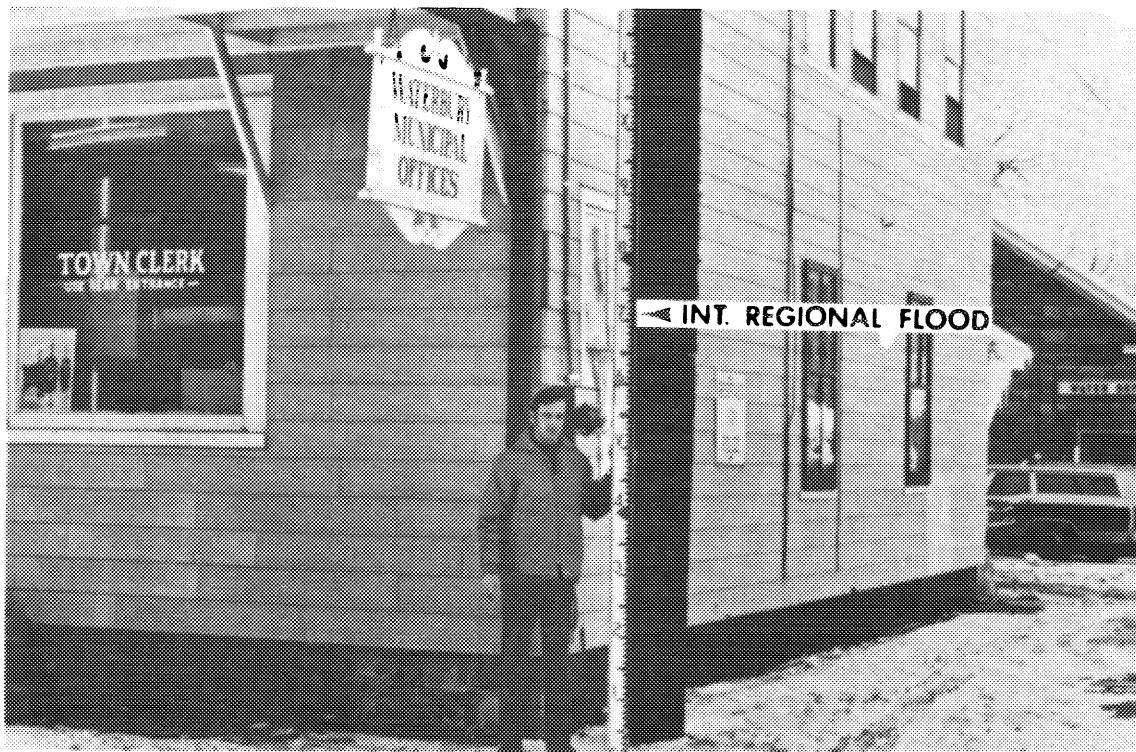
**Figure 19** - Future flood height at Waterbury Municipal Building.
